Manhole Inspection Summary

Manhole # S37Y1_030MH

Insp Date: **5/5/08 10:36 AM**

Location Address: **3824 3rd St.**

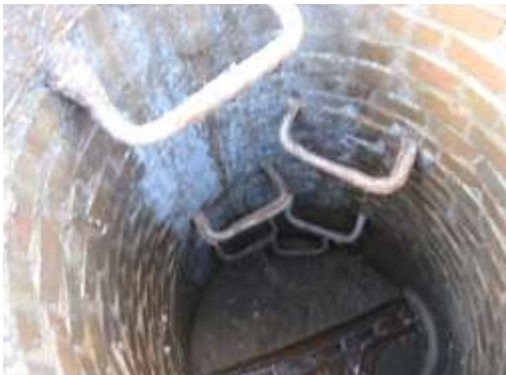
Steps

Count: **6** Missing: **0** ☒ Corroded

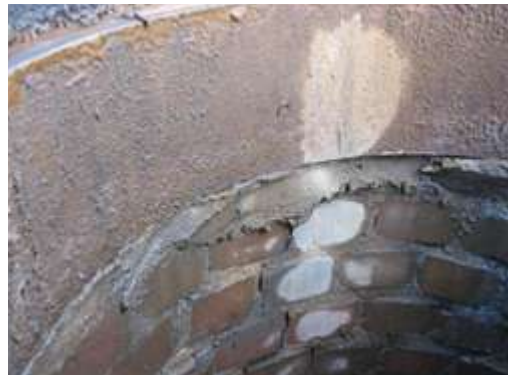
Defect 2

Infiltration: ☐ None ☒ Joint ☒ Cracks ☐ Mortar ☐ Roots ☐ Wall

Joint/Cracks

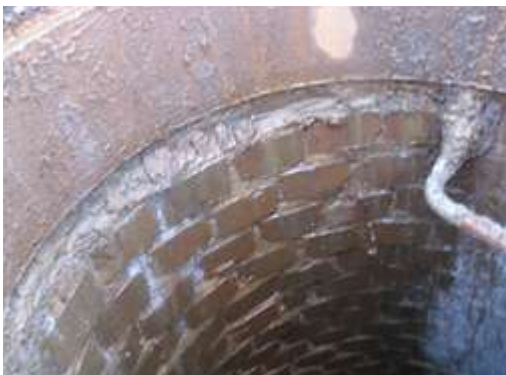
Defect 1

Infiltration: ☐ None ☐ Joint ☐ Cracks ☐ Mortar ☐ Roots ☒ Wall

Wall

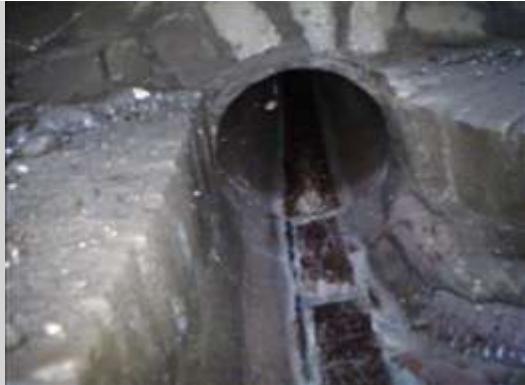
12 O'Clock Outflow

8 in. Circular Gravity Sewer
Pipe Out @ 12 O'Clock

Pipe Height: **10.8** (in.) Rod and Bar (Angled)
Pipe Material: **Clay** ☐ Pipe Lined
Invert Depth: **10.12** (ft.) Flow Characteristics: **Fast**
Deposits: ☒ None ☐ Mud ☐ Sludge ☐ Debris ☐ Grease
Silt Depth: (in.) Deposits Extent:
Infiltration: **None** Pipe Seal Cond: **Sound**

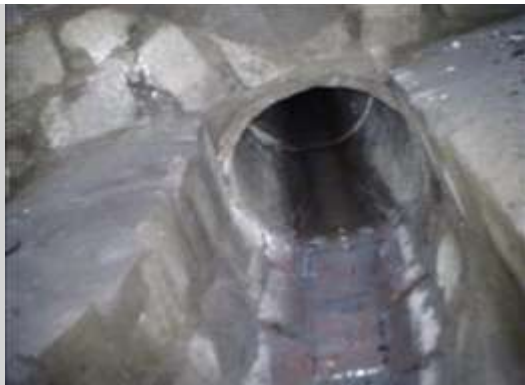
3 O'Clock Inflow

8 in. Circular Gravity Sewer
Pipe In @ 3 O'Clock

Pipe Height: **9.6** (in.) Rod and Bar (Angled)
Pipe Material: **Clay** ☐ Pipe Lined
Invert Depth: **9.84** (ft.) Flow Characteristics: **Fast**
Deposits: ☒ None ☐ Mud ☐ Sludge ☐ Debris ☐ Grease
Silt Depth: (in.) Deposits Extent:
Infiltration: **None** Pipe Seal Cond: **Sound**

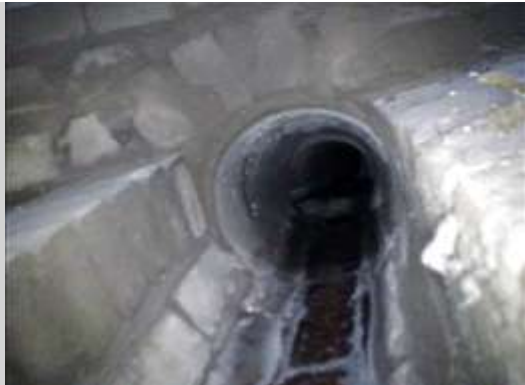
6 O'Clock Inflow

8 in. Circular Gravity Sewer

Pipe In @ 6 O'Clock

Pipe Height: **10.8** (in.) Rod and Bar (Angled)

Infiltration: **None** Pipe Seal Cond: **Sound**
